# EPA AWARDS 2019

▶ CATEGORY 2: "INTERPARKING - INDUSTRIE"

EPA Awards 2019 | Category 2: "Interparking – Industrie, BE Brussels - Belgium"

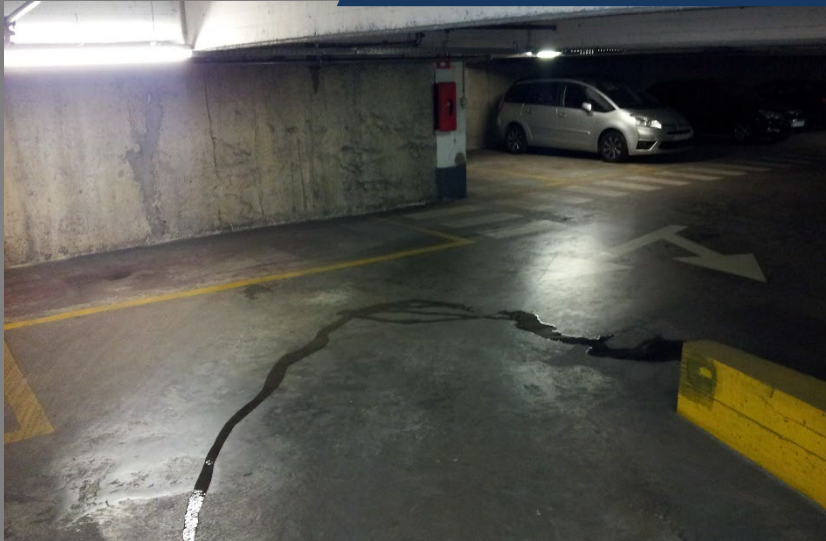
BEFORE

AFTER

TREATED WITH CHLORINE, THE WATER STARTED TO ATTACK THE CONCRETE AND THE IRON REINFORCEMENTS IN IT.

WE THEREFORE HAD TO CONDUCT A COMPLETE MAKE-OVER : WITH NEW STRUCTURE, EXTENSIVE FLOORCOATING AND WALLPAINTING. RESULTING IN A CLEAN AND PLEASANT ENVIRONMENT.

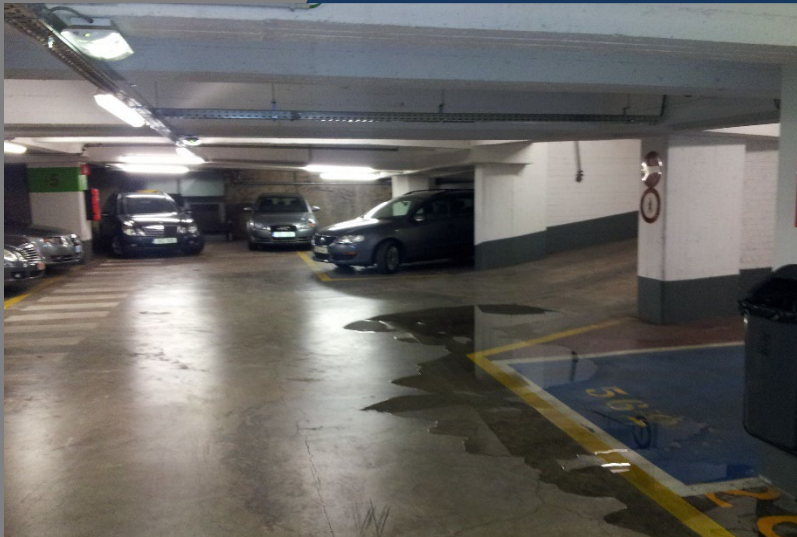
BEFORE

AFTER

THANKS TO LED LIGHTING AND DIMING SYSTEMS, THE AUTOMATIC LIGHTS  
TURN ON WHEN A MOVE IS DETECTED...

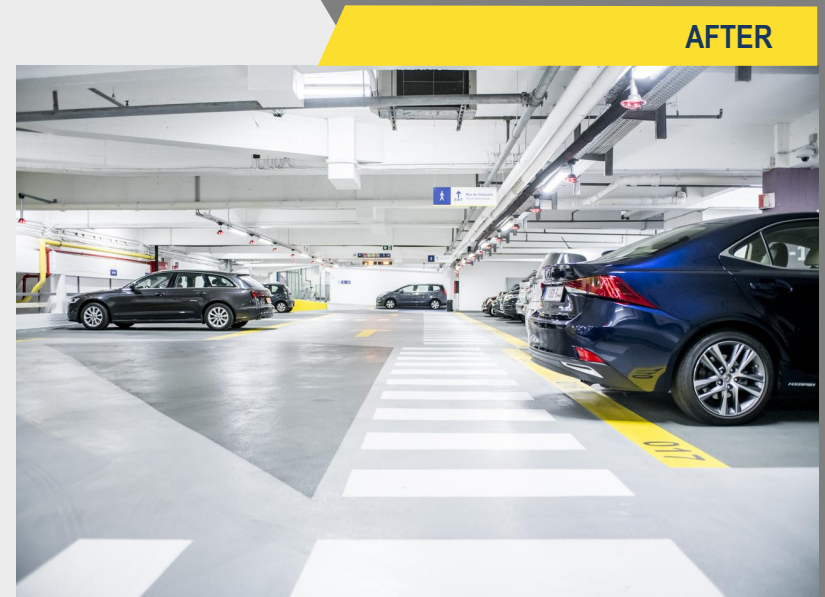
... ALLOWINGS A LIGHTER ENVIRONMENT AT LOWER COSTS.

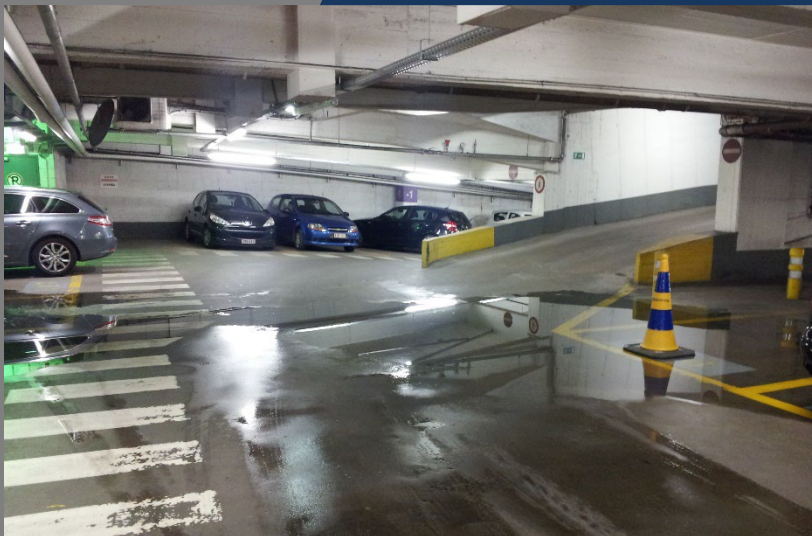
BEFORE

AFTER

THE FLOOR COATING ENSURES NOW THAT NO LIQUIDS (WATER, BUT ALSO FUEL OR OIL FROM CARS) WILL PASS, TO PREVENT SOIL POLLUTION.
